Recreational Use Attainability Analysis for Buffalo Creek (0214B), Paradise Creek (0230A), and Sweetwater Creek (0299A) in the Red River Basin

DRAFT for PUBLIC REVIEW

Prepared for:
Texas State Soil and Water Conservation Board
Project 12-52

TR 1308

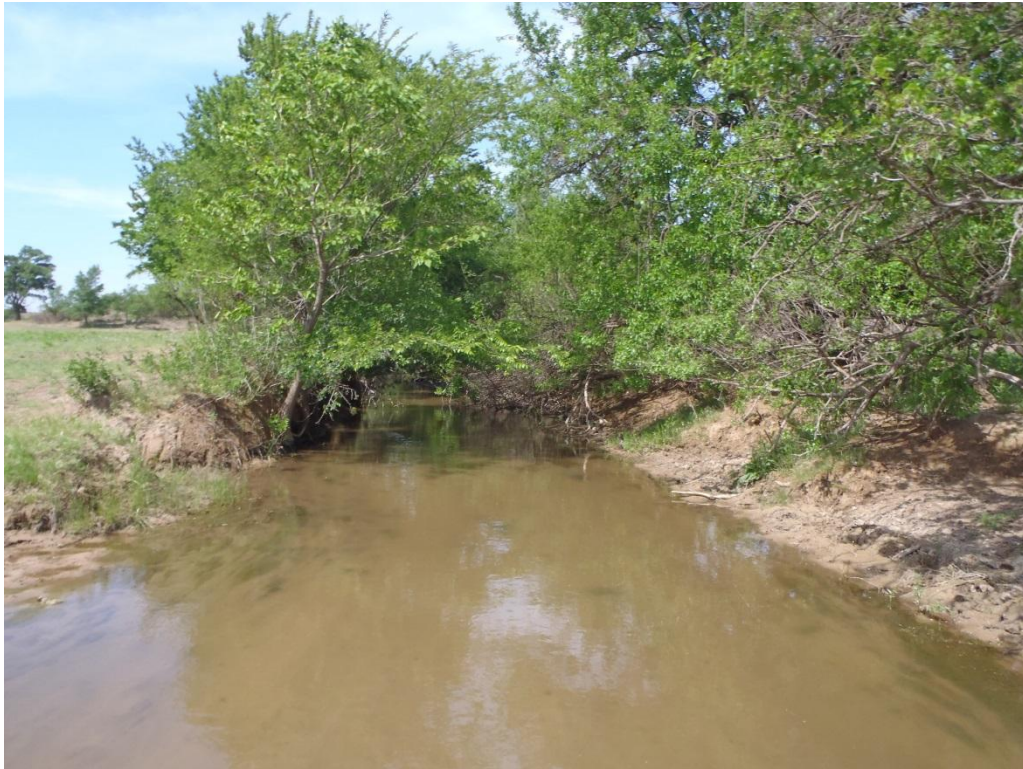
Figure 5.14 Photograph of Sweetwater Creek Site SW006 taken on May 26, 2013, the upstream view of the 150-m transect.

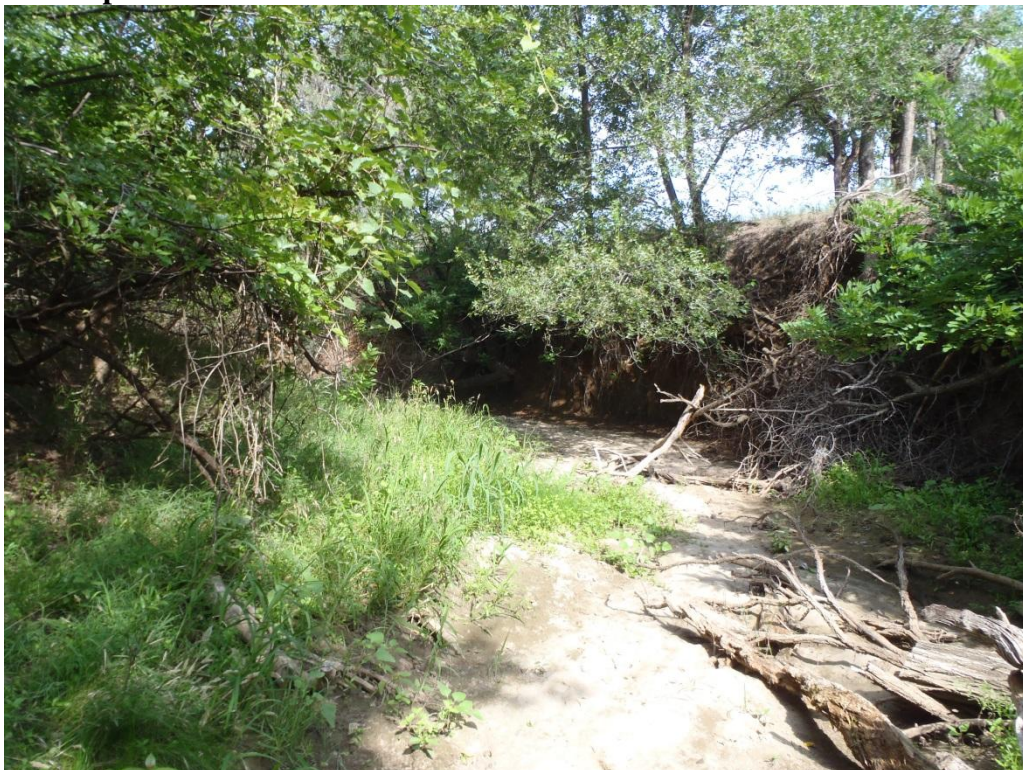
Figure 5.15 Photograph of Sweetwater Creek Site SW006 taken on July 29, 2013, the upstream view of the 30-m transect.

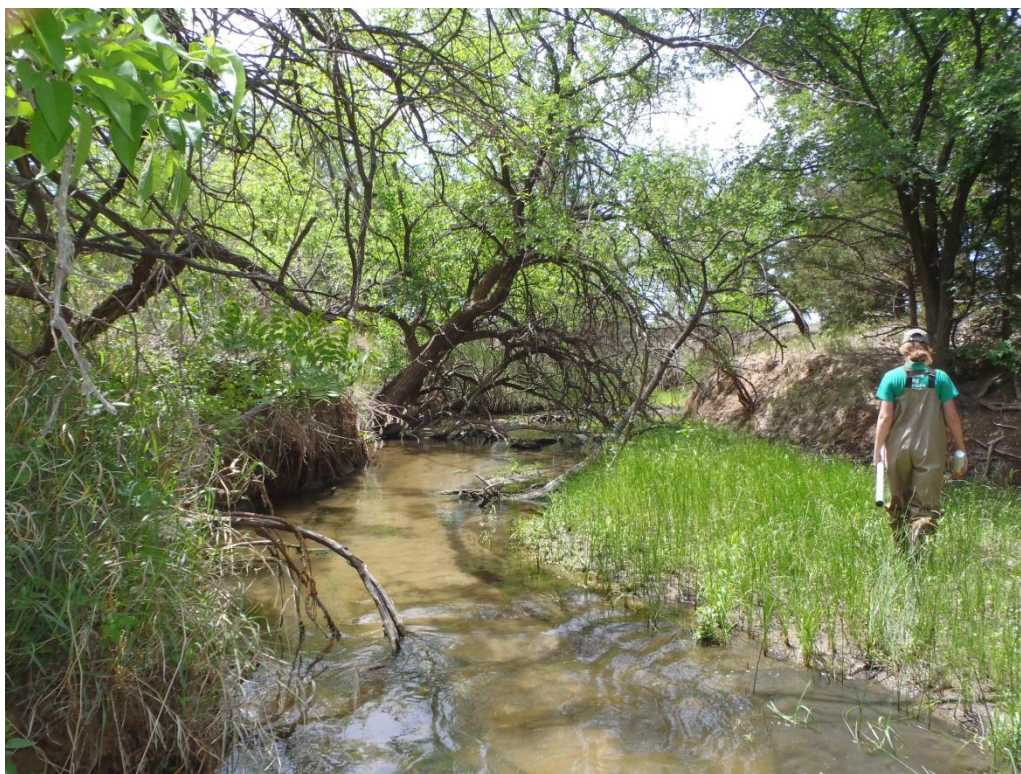
Figure 5.16 Photograph of Sweetwater Creek Site SW007 taken on May 26, 2013, the upstream view of the 300-m transect. TIAER personnel in photograph.

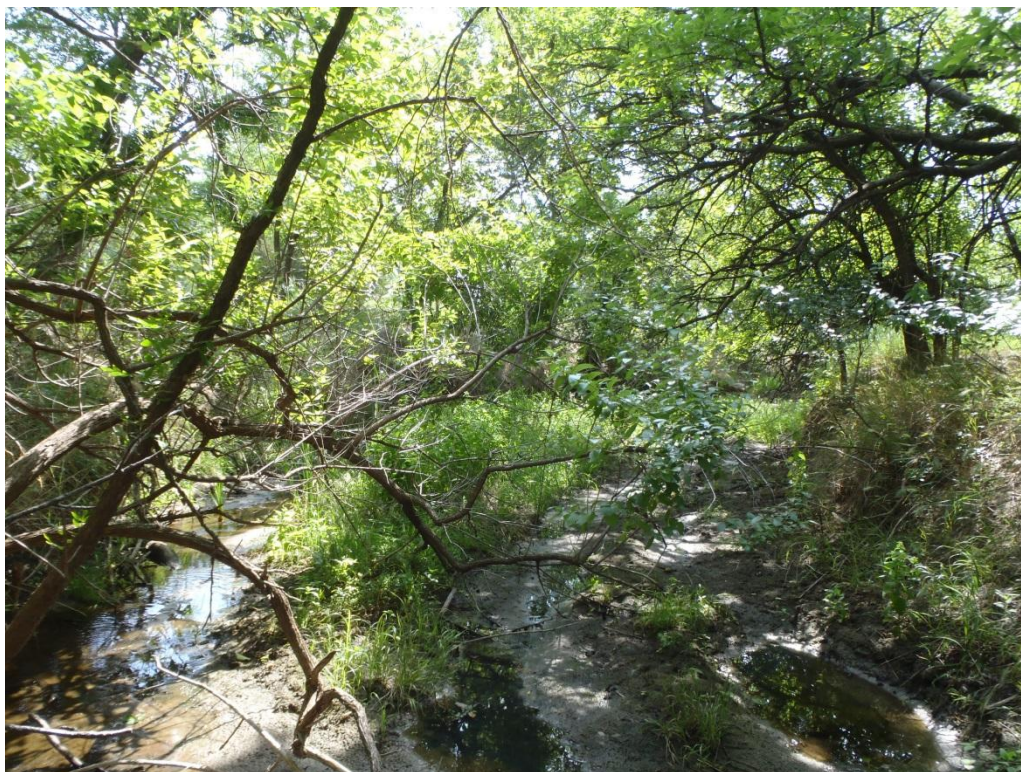
Figure 5.17 Photograph of Sweetwater Creek Site SW007 taken on July 29, 2013, the upstream view of the 30-m transect.

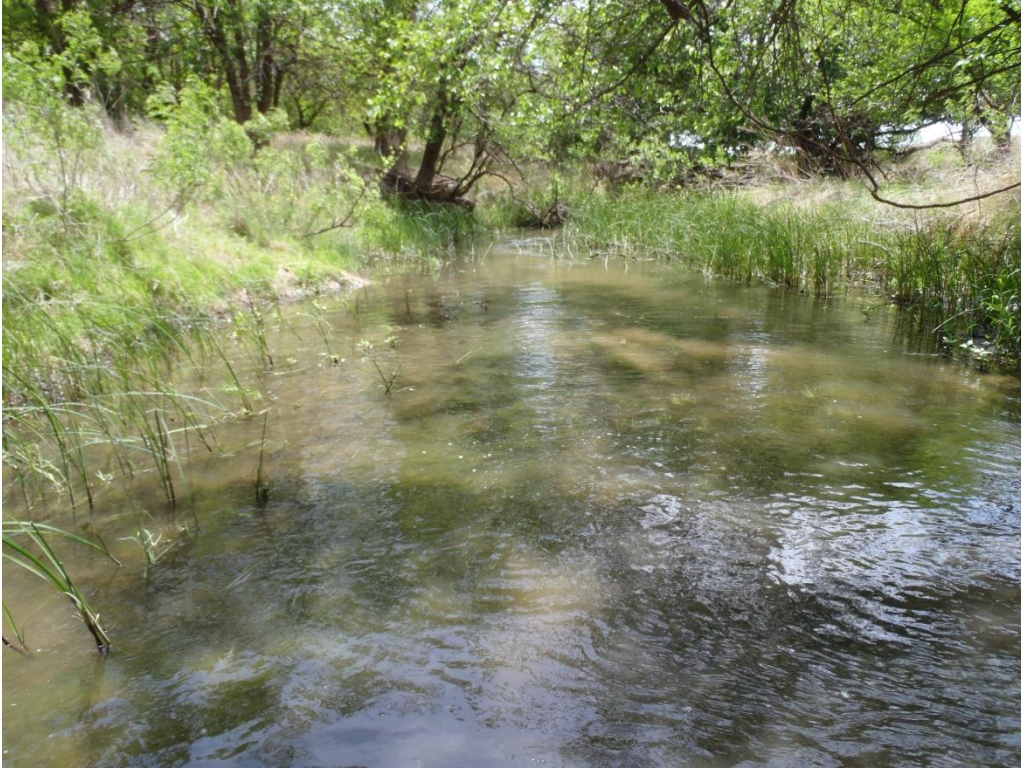
Figure 5.19 Photograph of Sweetwater Creek Site SW008 taken on May 26, 2013, the downstream view of the 300-m transect.

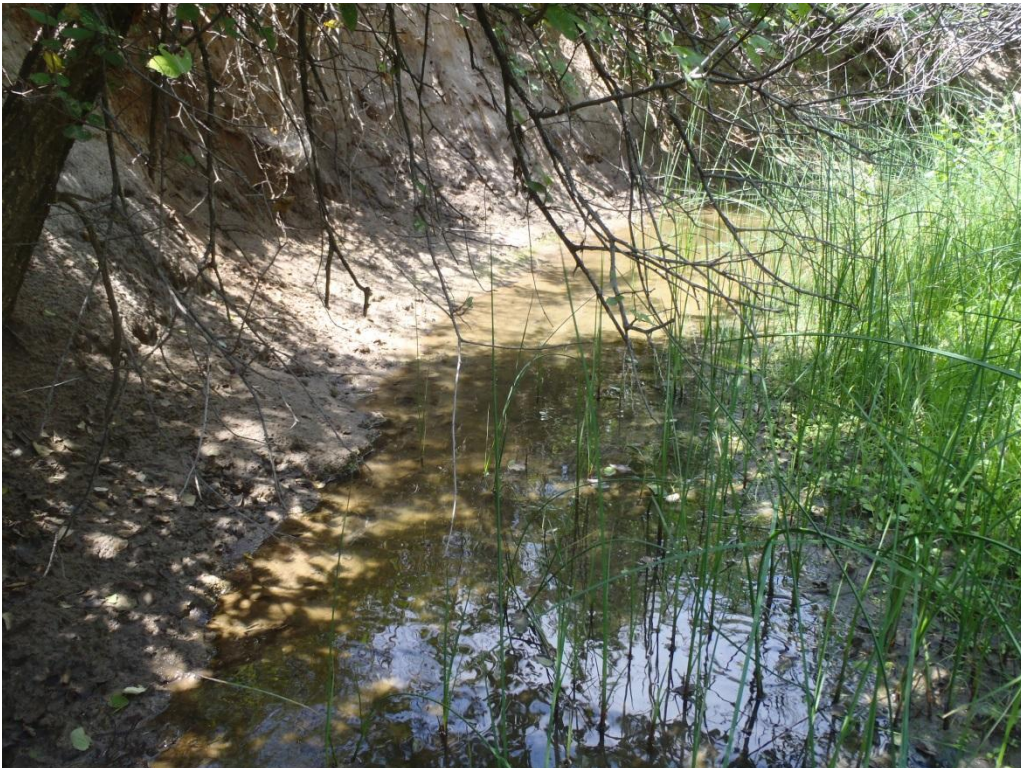
Figure 5.20 Photograph of Sweetwater Creek Site SW008 taken on July 29, 2013, the upstream view of the 150-m transect.

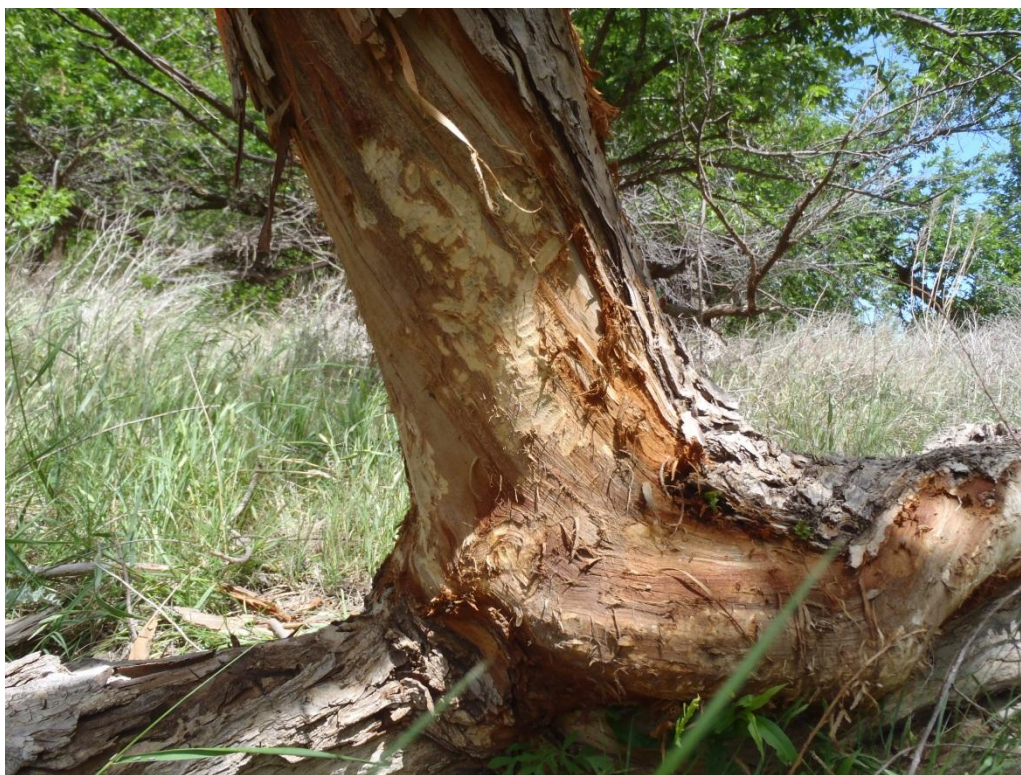
Figure 5.21 Photograph of Sweetwater Creek Site SW008 taken on July 29, 2013 showing typical gnaw marks observed on several trees within the survey reach.

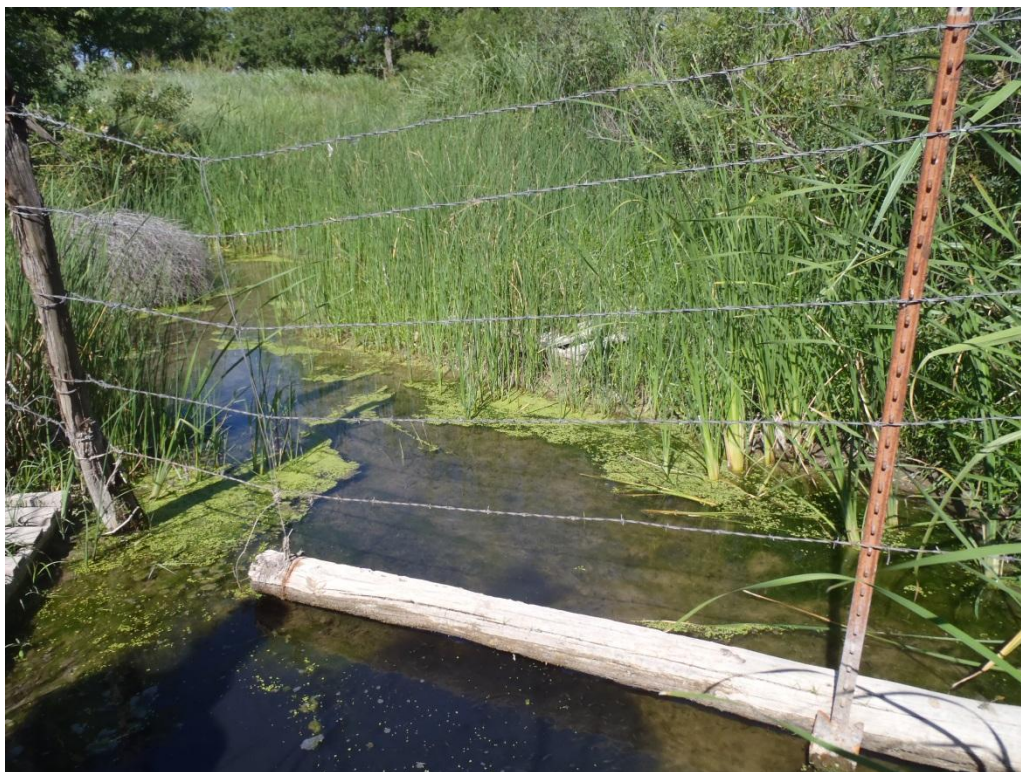
Sweetwater Creek at site SW009 was visited on May 26 and July 28, 2013. This site, located east of Wheeler, Texas in Wheeler County, was accessible only through private lands that were fenced and required landowner cooperation to enter the property. With landowner permission, TIAER personnel drove underneath the Ranch Road 592 bridge crossing and crossed a private property fence to conduct the entire 300 meter length of the reach. Although this site is listed as being publicly accessible, it is only accessible to the public for approximately 20 meter upstream and downstream of the bridge. Water gaps cross the stream impeding persons from traversing the stream in both directions (Figure 5.22).

Figure 5.22 Photograph of Sweetwater Creek Site SW009 taken on July 28, 2013 showing the water gap downstream of the bridge.

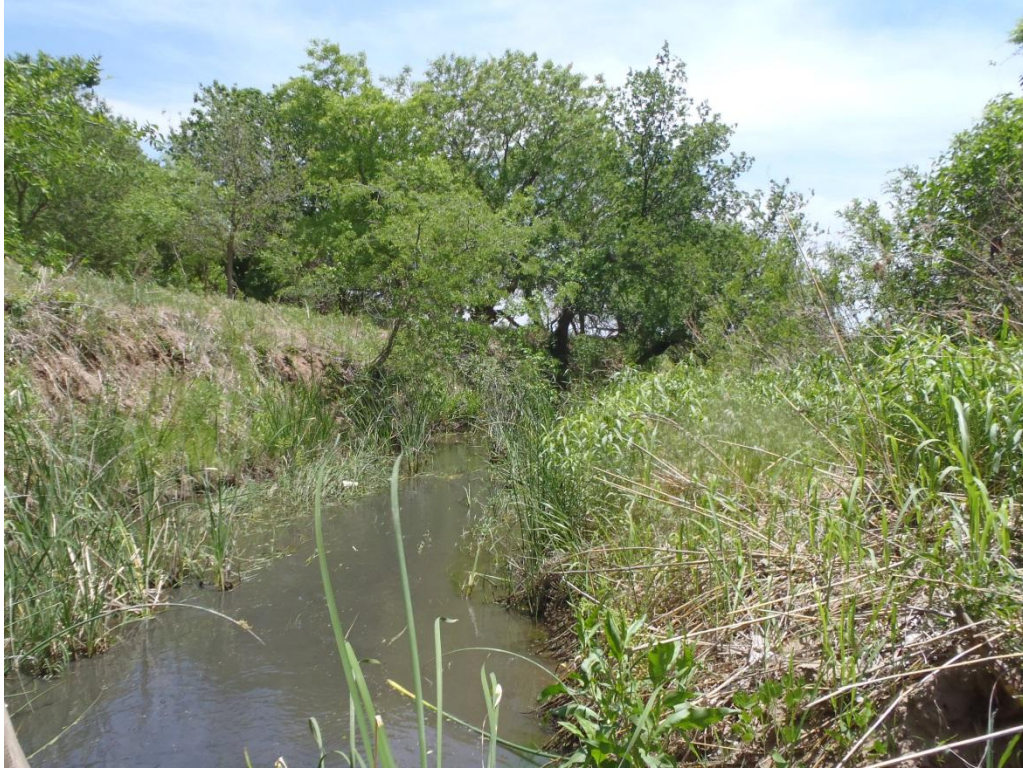
Figure 5.23 Photograph of Sweetwater Creek Site SW009 taken on May 26, 2013, the downstream view of the 30-m transect.

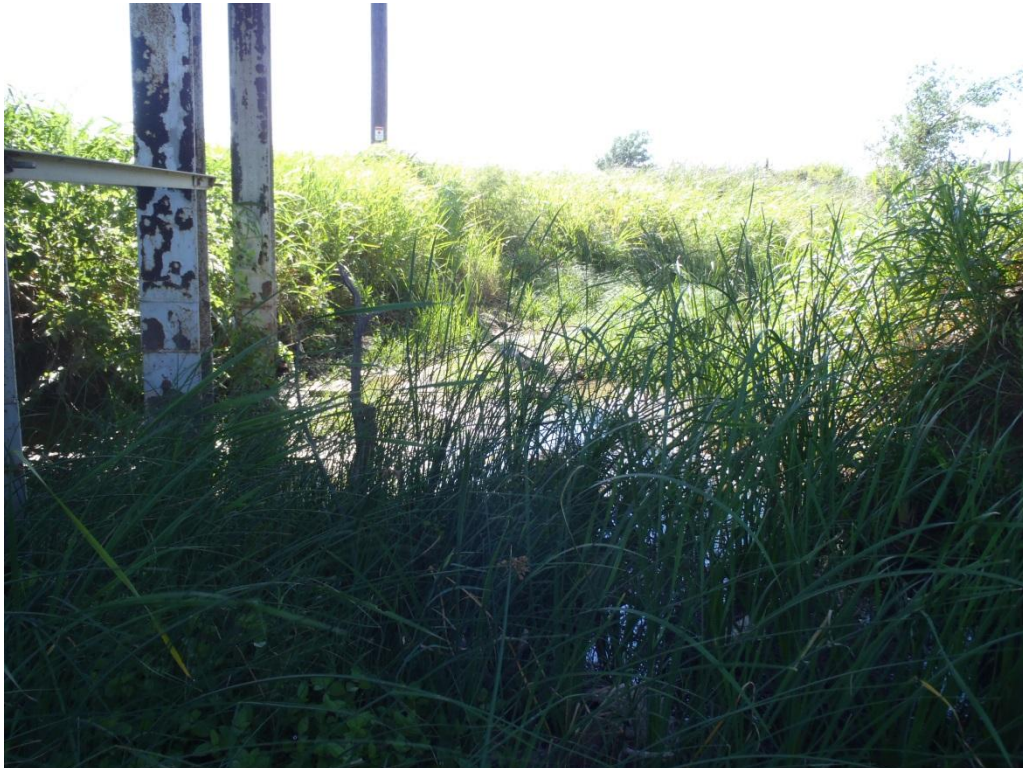
Figure 5.24 Photograph of Sweetwater Creek Site SW009 taken on July 28, 2013, the upstream view of the 300-m transect.

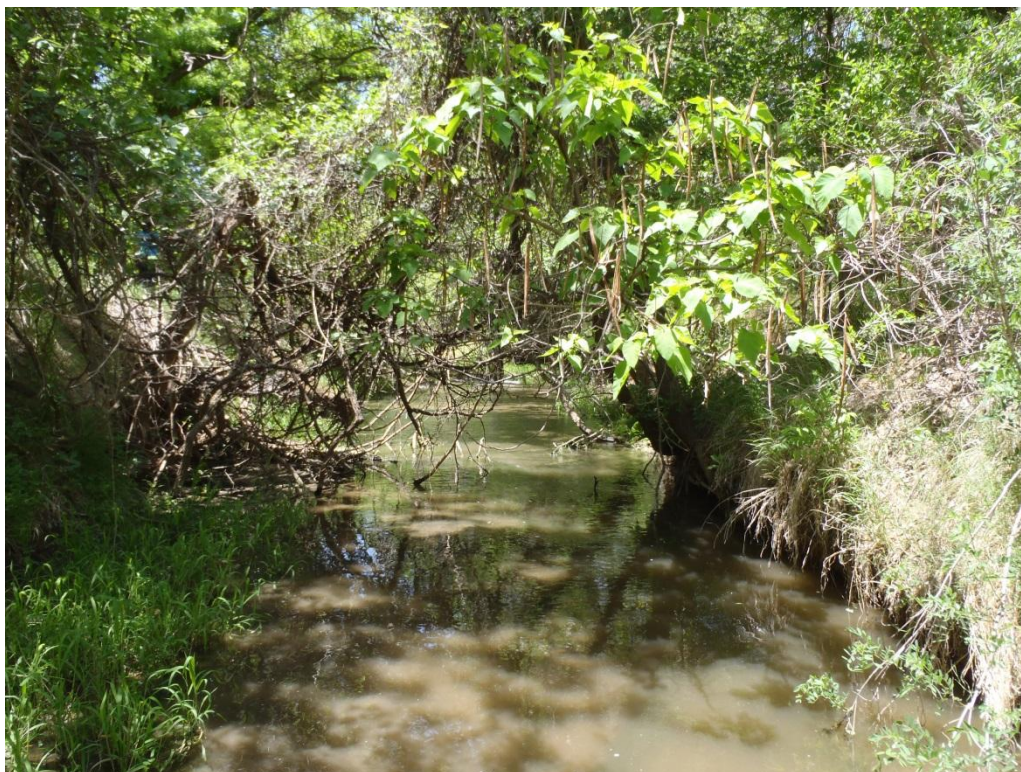
Figure 5.25 Photograph of Sweetwater Creek Site SW010 taken on May 27, 2013, the upstream view of the 30-m transect.

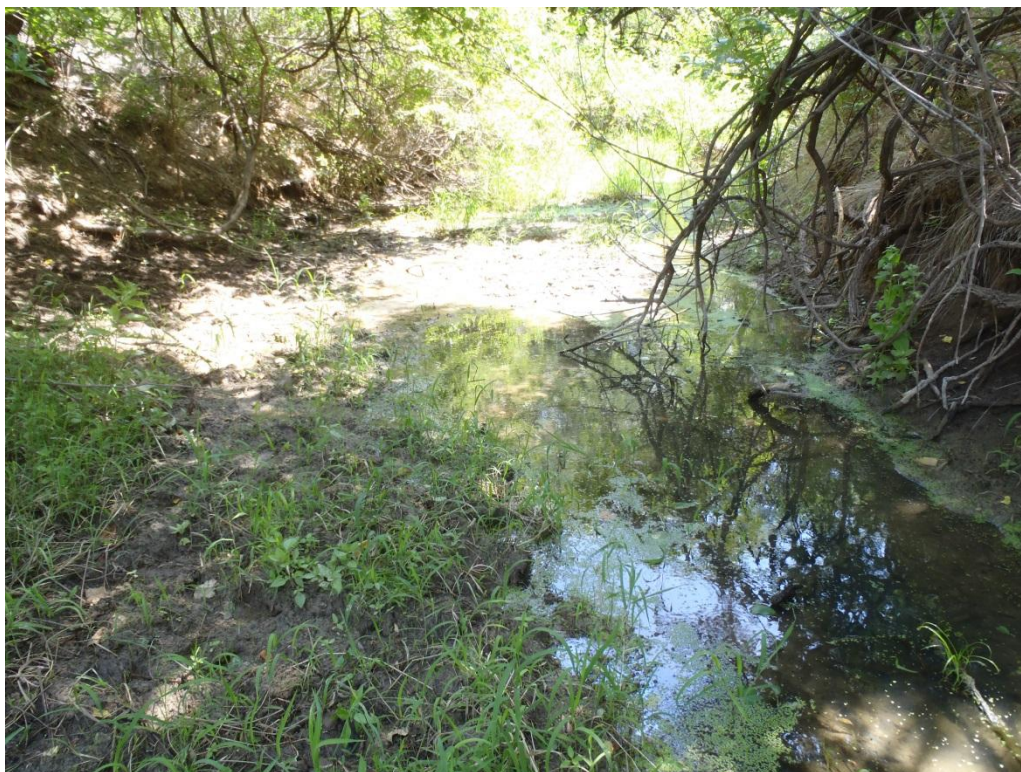
Figure 5.26 Photograph of Sweetwater Creek Site SW010 taken on July 29, 2013, the downstream view of the 150-m transect.

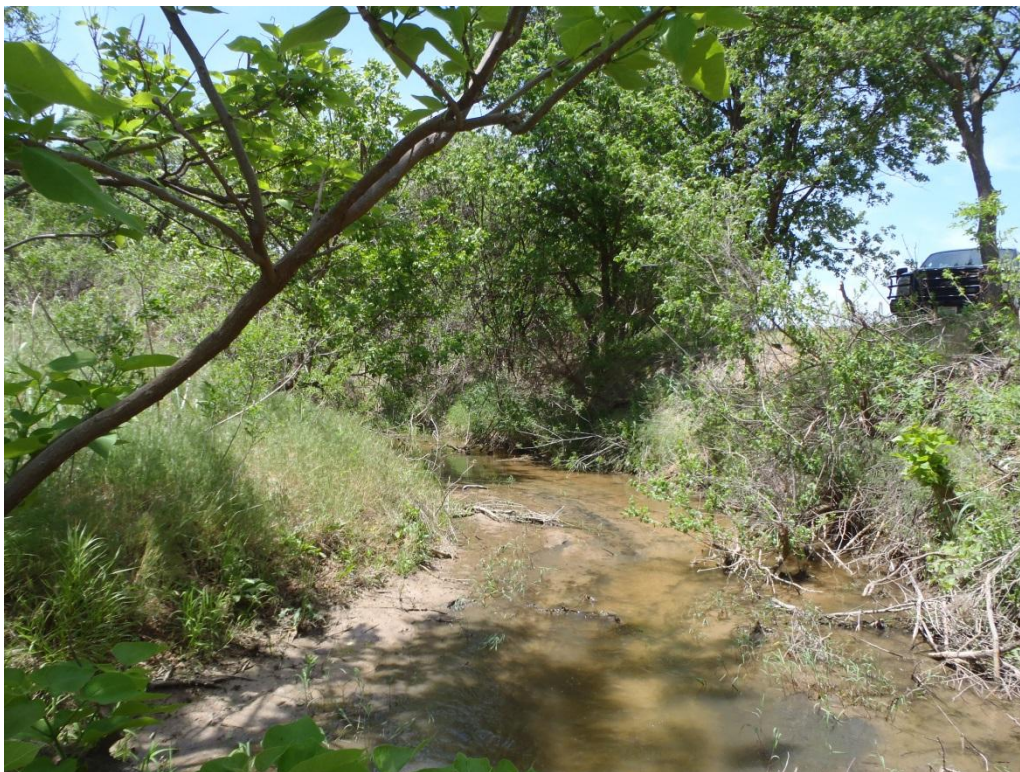
Figure 5.27 Photograph of Sweetwater Creek Site SW011 taken on May 26, 2013, the upstream view of the 300-m transect. TIAER vehicle in background.

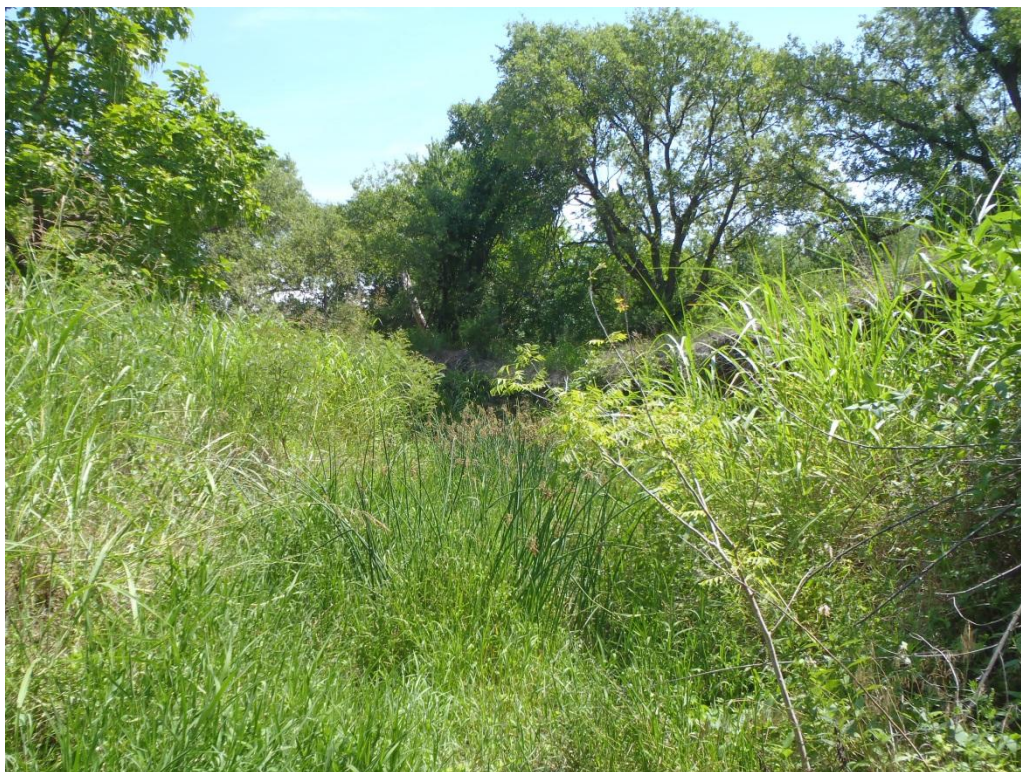
Site SW011 was wadeable for the entire 300-m reach length. Average thalweg ranged from 0.26 m during the first survey to 0.09 m during the second survey when the stream was significantly lower (Table 5.6). During both surveys, the shallow water depths with primarily sandy substrate made wading in the stream channel easy for most of the reach. Widths of the stream ranged from a maximum of 4.0 m during the first survey to a minimum of 0.0 m during the second survey (Tables 5.7 and 5.8). Log obstructions, overhanging trees and dense aquatic vegetation encountered during both surveys made traversing the streambed sometimes challenging.

Figure 5.28 Photograph of Sweetwater Creek Site SW011 taken on July 29, 2013, the downstream view of the 150-m transect.

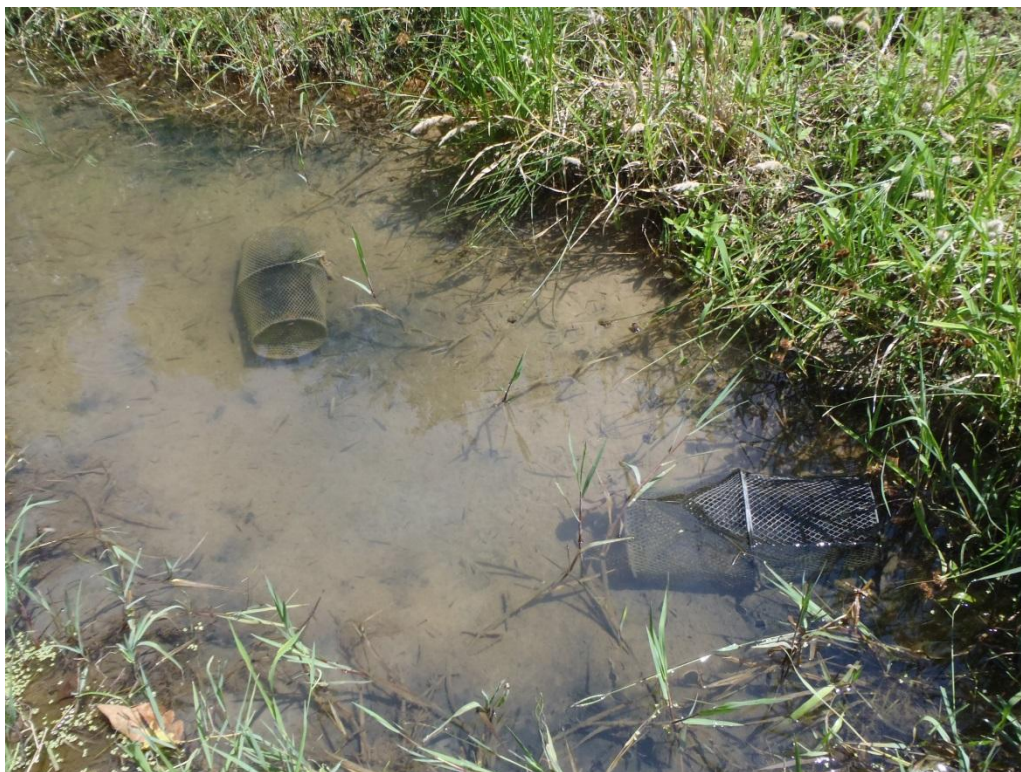
Aquatic vegetation was common during both surveys, while algae was common during the first survey and absent during the second survey. Water color was clear and green during the first survey and clear during the second survey with no surface scum or foam observed during either survey. Trash was rarely observed throughout the reach and when encountered, consisted of typical plastics, aluminum cans, bottles, tires and pieces of lumber. The only evidence of recreational activity was observed during the second survey in the form of two minnow traps found near the 120-m transect as shown in Figure 5.29. Ropes were attached to each trap and ran up the steep bank. Conversations with the landowner revealed that the son of the landowner use these traps with the intention of fishing at one of the tanks on the property.

Figure 5.29 Photograph of Sweetwater Creek Site SW011 taken on July 29, 2013 showing two minnow traps in the stream near the 120-m transect.

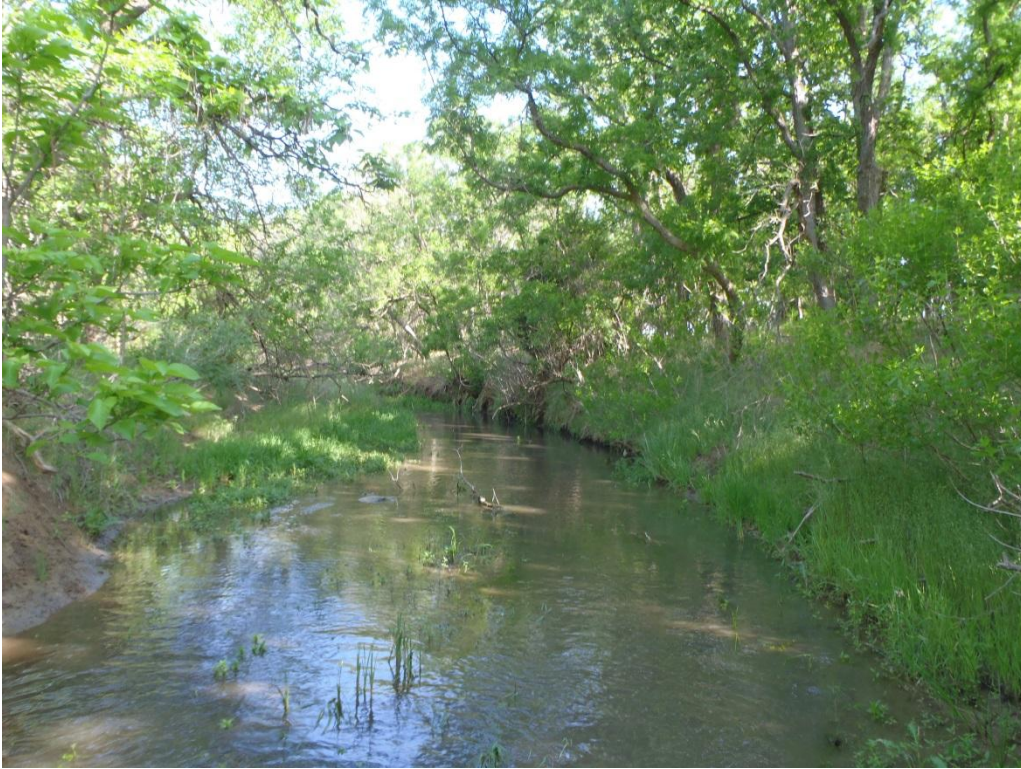
Figure 5.30 Photograph of Sweetwater Creek Site SW012 taken on May 27, 2013, the upstream view of the 300-m transect.

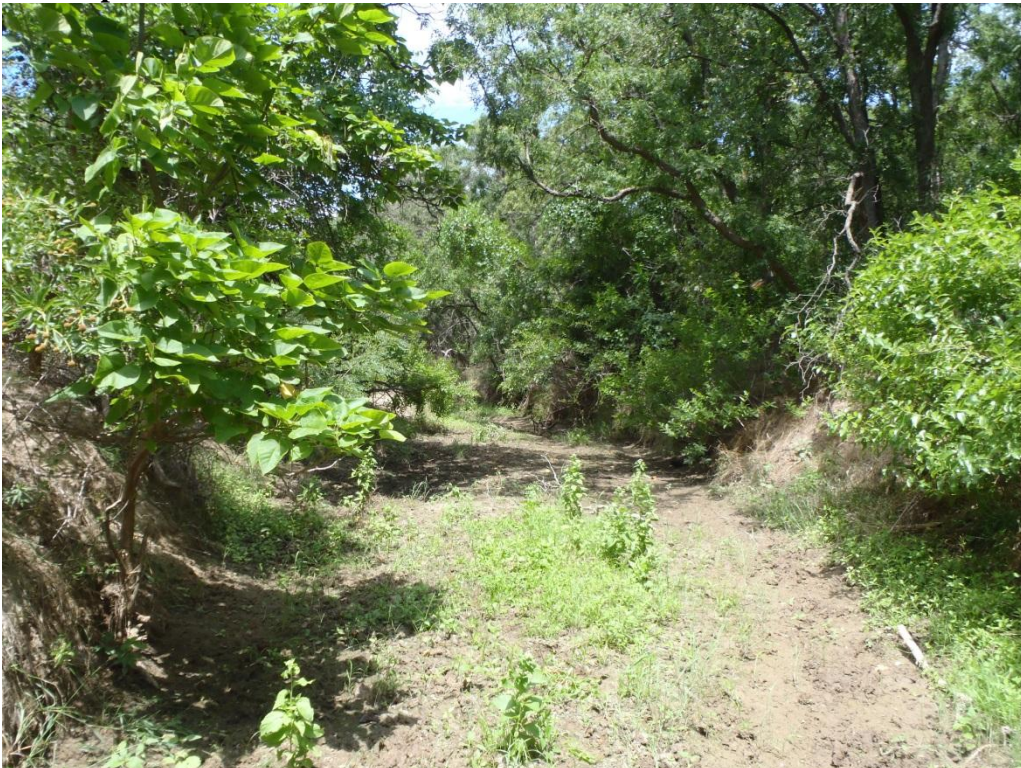
Figure 5.31 Photograph of Sweetwater Creek Site SW012 taken on July 29, 2013, the upstream view of the 300-m transect.

Site SW012 was wadeable for the entire 300-m reach length. Average thalweg ranged from 0.31 m during the first survey to 0.04 m during the second survey when the stream was significantly lower (Table 5.6). During both surveys, the shallow water depths with primarily sandy substrate made wading in the stream channel easy for most of the reach. Widths of the stream ranged from a maximum of 5.7 m during the first survey to a minimum of 0.0 m during the second survey when only pockets of water were encountered (Tables 5.7 and 5.8). A couple of log obstructions were encountered during both surveys.

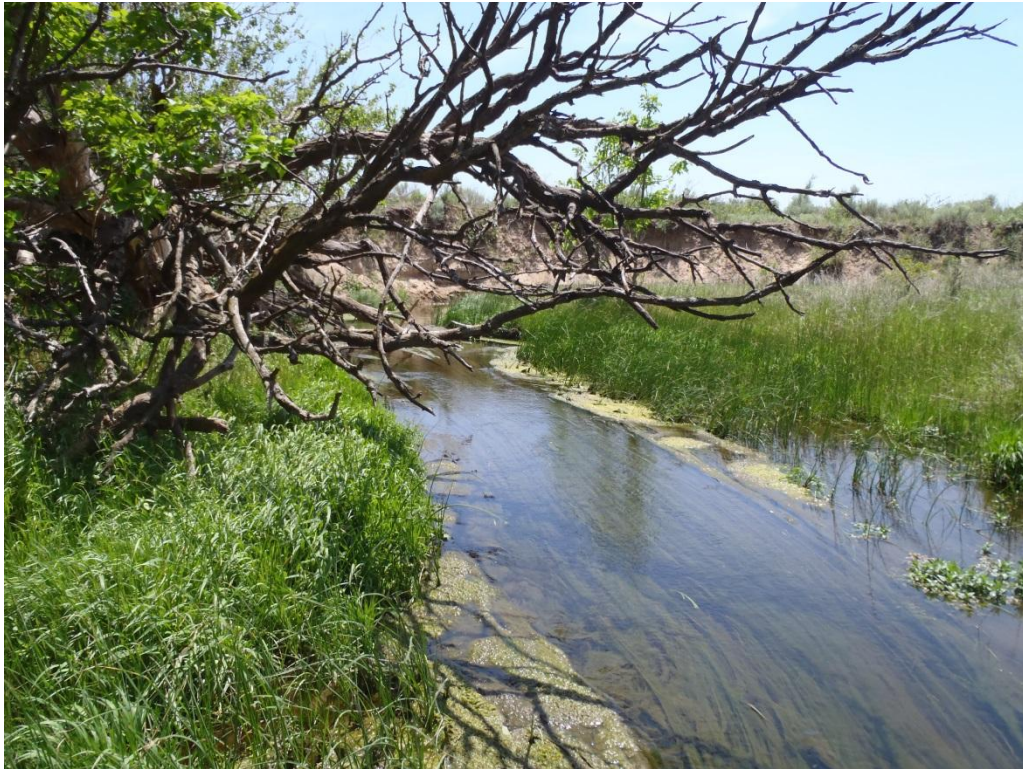
Figure 5.32 Photograph of Sweetwater Creek Site SW013 taken on May 26, 2013, the upstream view of the 150-m transect.

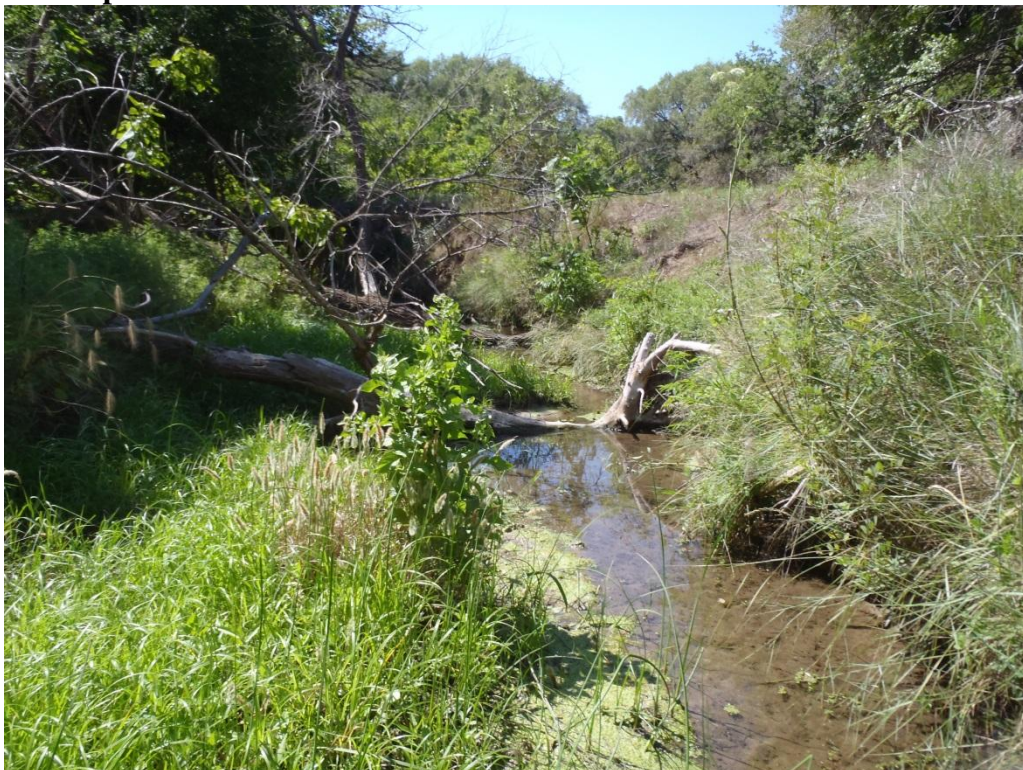
Figure 5.33 Photograph of Sweetwater Creek Site SW013 taken on July 28, 2013, the upstream view of the 300-m transect.

Site SW013 was wadeable for the entire 300-m reach length. Average thalweg ranged from 0.35 m during the first survey to 0.08 m during the second survey when the stream was significantly lower (Table 5.6). During both surveys, the shallow water depths with the primarily sandy substrate made wading in the stream channel easy for most of the reach. Widths of the stream ranged from a maximum of 6.0 m during the first survey to a minimum of 0.4 m during the second survey when the stream was significantly lower (Tables 5.7 and 5.8). Tree obstructions and overhanging branches were encountered during both surveys, which made traversing the stream sometimes challenging.

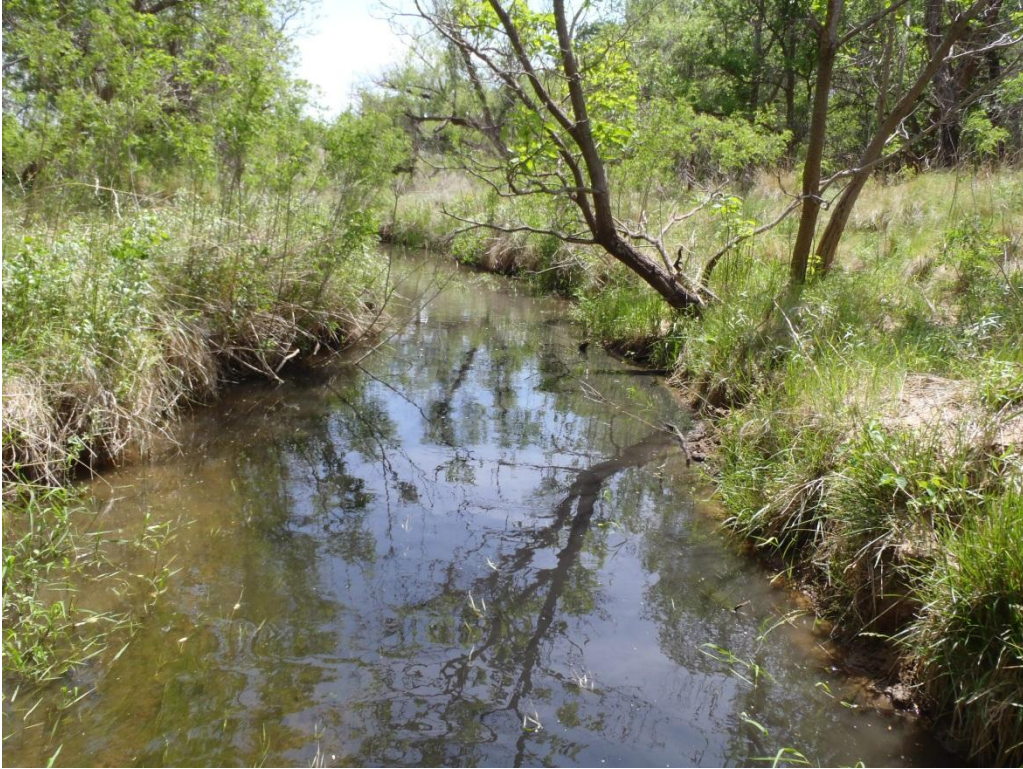
Figure 5.34 Photograph of Sweetwater Creek Site SW014 taken on May 26, 2013, the downstream view of the 150-m transect.

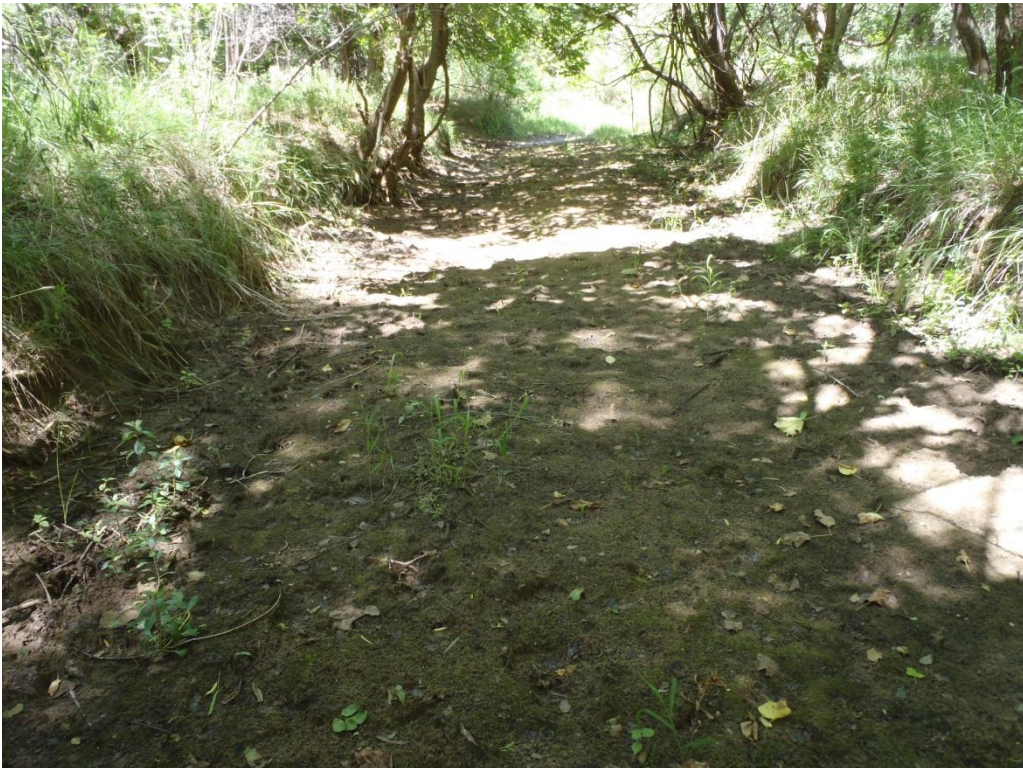
Figure 5.35 Photograph of Sweetwater Creek Site SW014 taken on July 28, 2013, the upstream view of the 300-m transect.

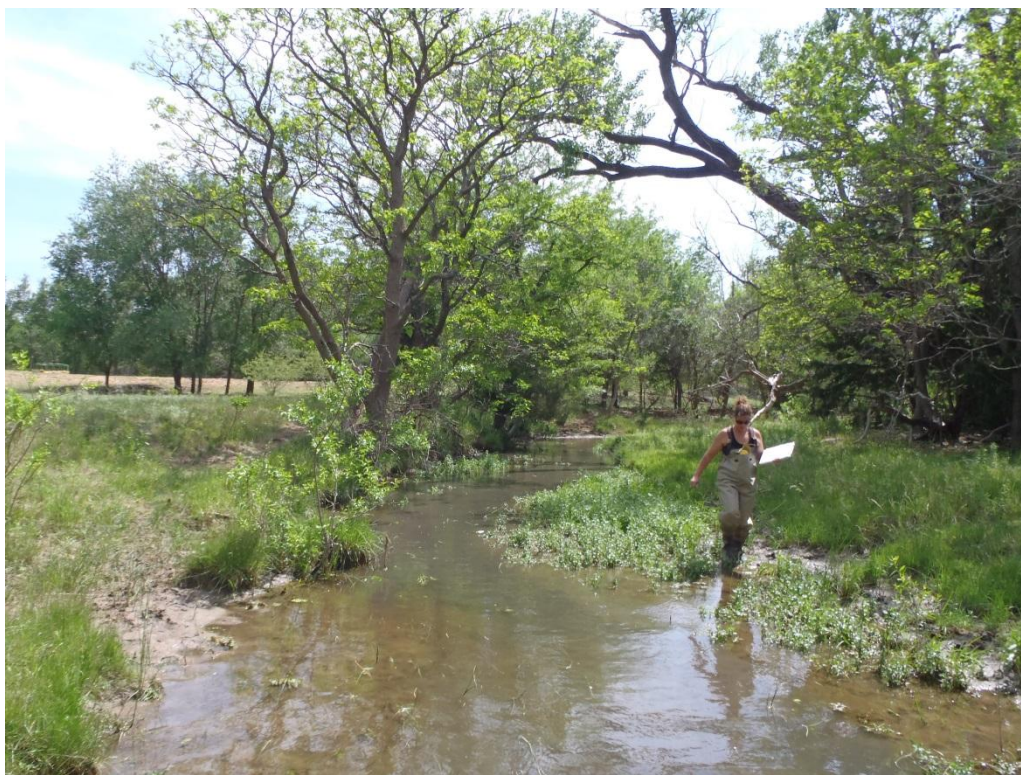
Figure 5.36 Photograph of Sweetwater Creek Site SW015 taken on May 26, 2013, the upstream view of the 30-m transect. TIAER personnel in photograph.

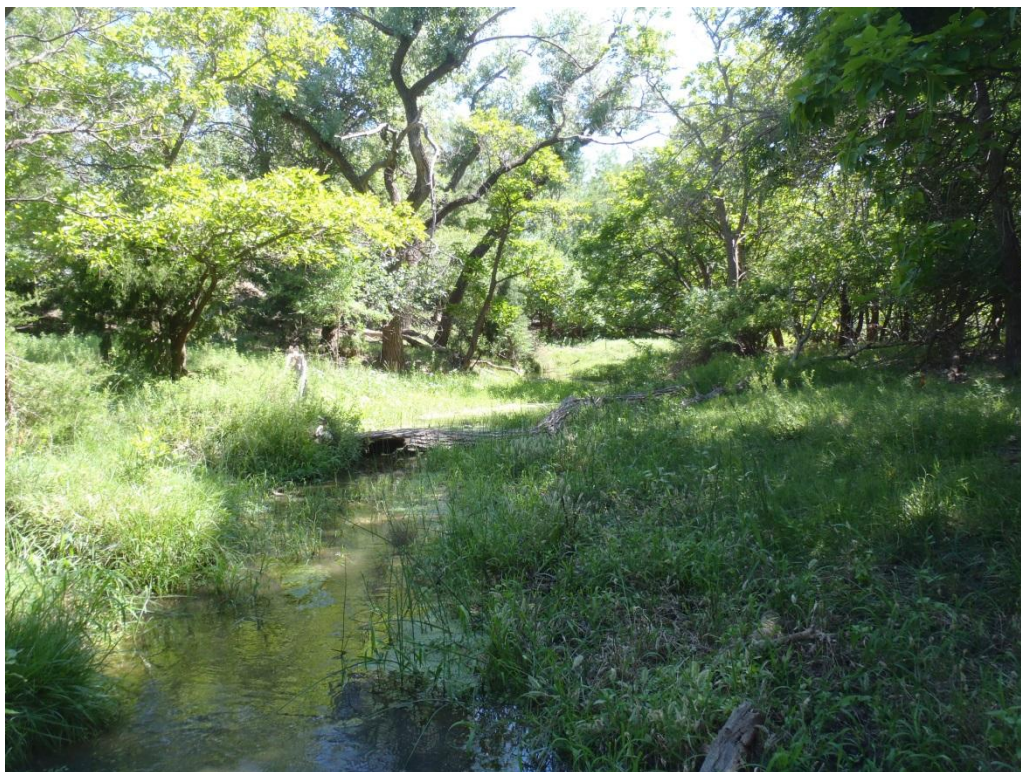
Figure 5.37 Photograph of Sweetwater Creek Site SW015 taken on July 28, 2013, the upstream view of the 150-m transect.

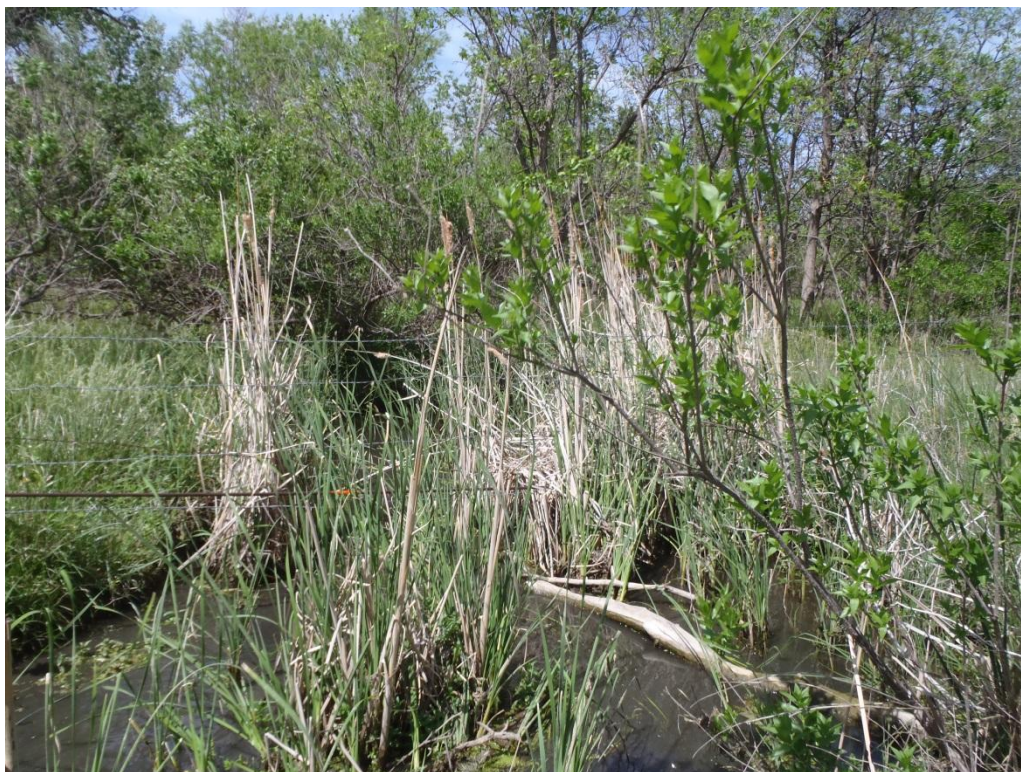
Site SW015 was wadeable for only 290 m of the 300-m reach length. A barbed wire property boundary fence located at the 10-m transect prevented TIAER personnel from completing the entire 300-m length of the reach (Figure 5.38). Average thalweg ranged from 0.18 m during the first survey to 0.11 m during the second survey (Table 5.6). During both surveys, the sandy substrate and shallow water depths made wading in the stream channel easy. Widths of the stream ranged from a maximum of 3.7 m during the first survey to a minimum of 1.0 m during the second survey (Tables 5.7 and 5.8). Other than the barbed wire fence obstruction, the only other obstructions were tree obstructions encountered during both surveys.

Figure 5.38 Photograph of Sweetwater Creek Site SW015 taken on May 26, 2013, the barbed wire fence at the 10-m transect.

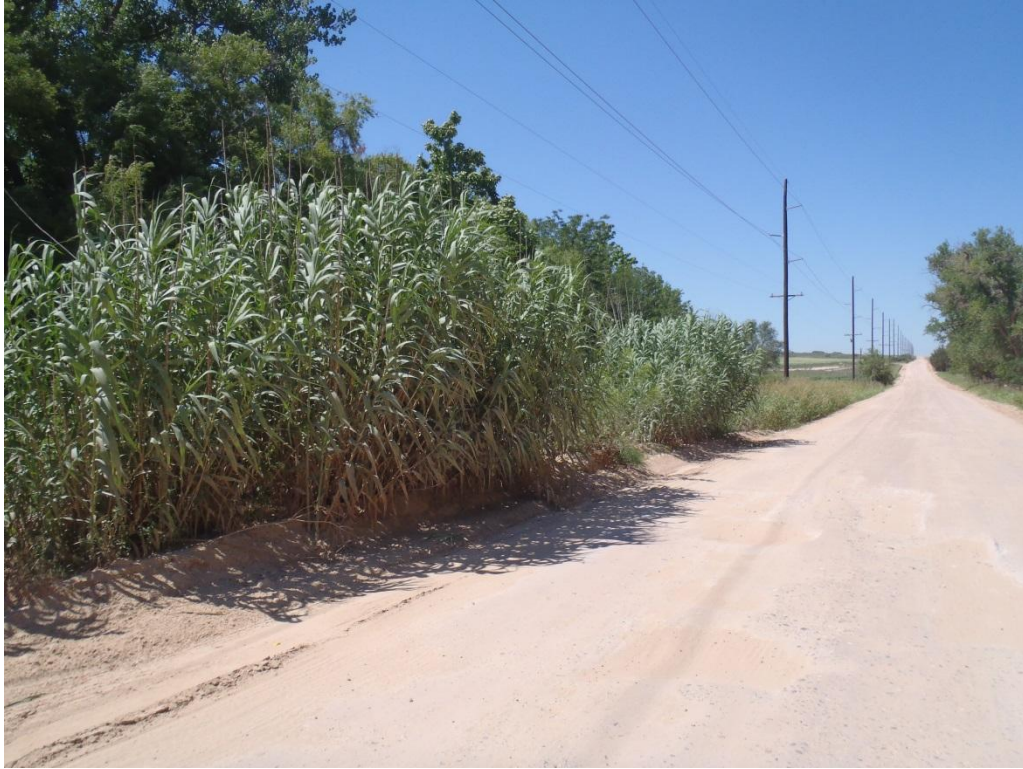
Figure 5.39 Photograph of Sweetwater Creek Site SW016 taken on July 28, 2013 showing public accessibility to the stream.

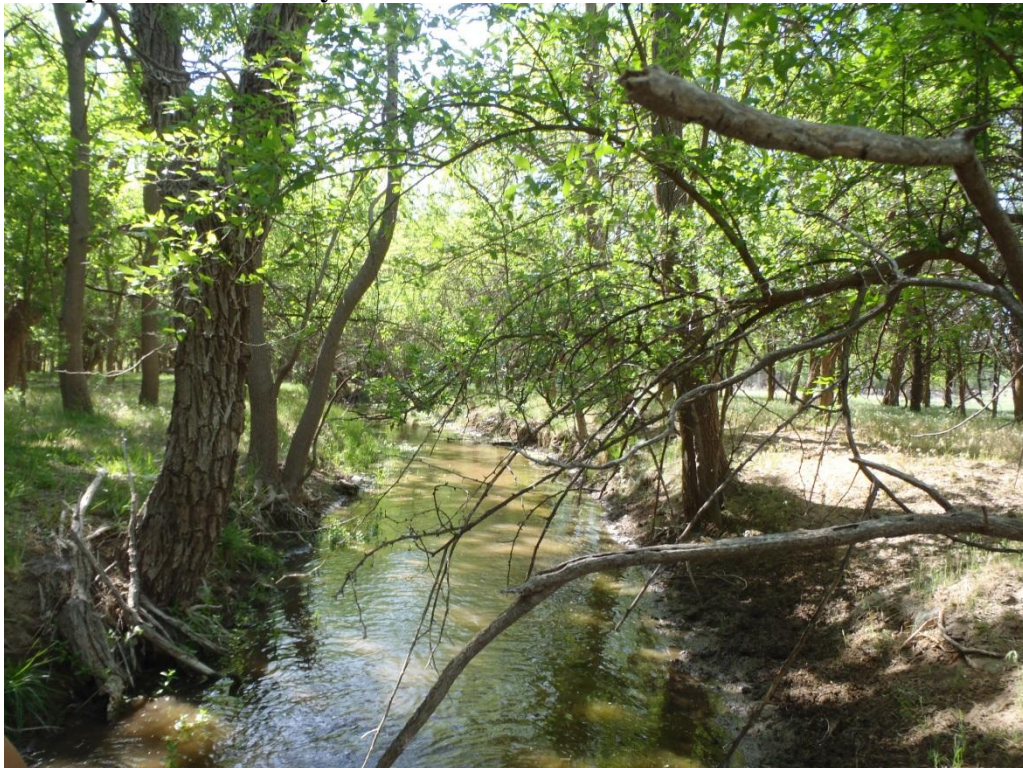
Figure 5.40 Photograph of Sweetwater Creek Site SW016 taken on May 27, 2013, the downstream view of the 150-m transect.
